# 2017 Emergency Repair Program PHOTO SUBMITTAL EXAMPLE

## EXAMPLES OF ACCEPTABLE REPAIRS

## EXAMPLES OF NON-ACCEPTABLE REPAIR

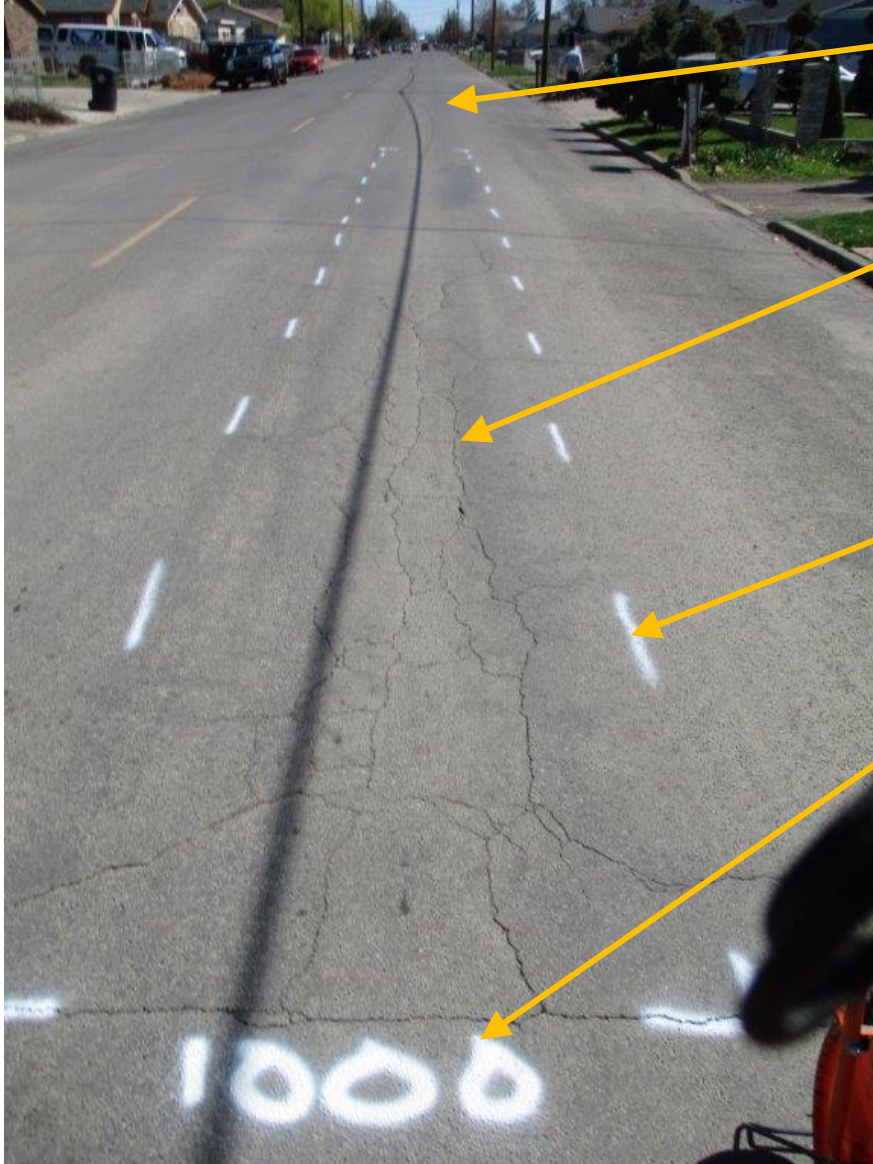
Good overall road perspective view

Pavement distress clearly visible with minimal disruption from shadows or other factors

Pavement marked for clear definition of repair

Repair area marked with identifying mark

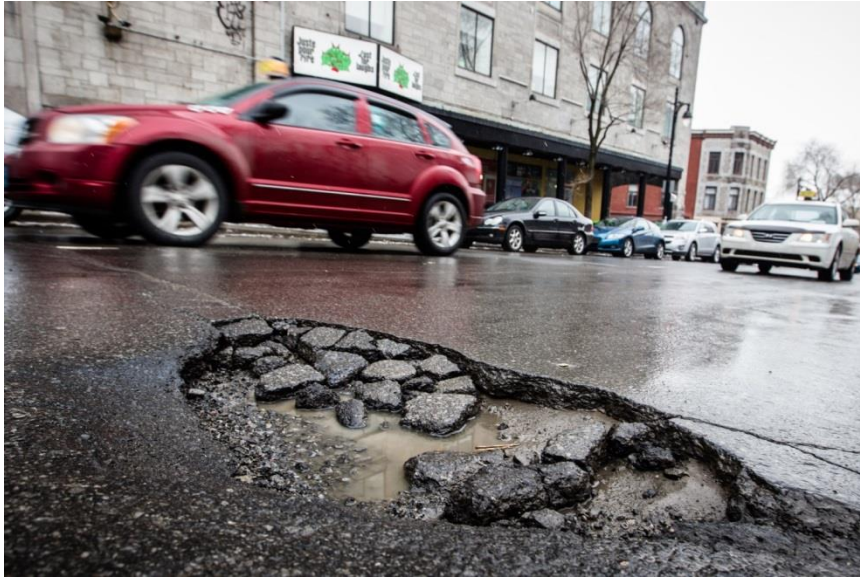
-Good Base

-Isolated Repair

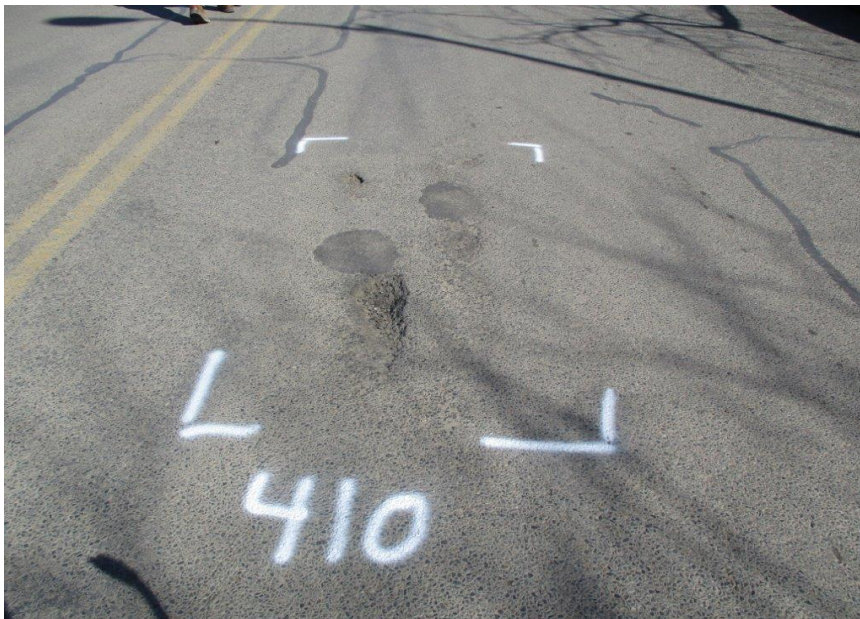
-Good Base

-Isolated Repair

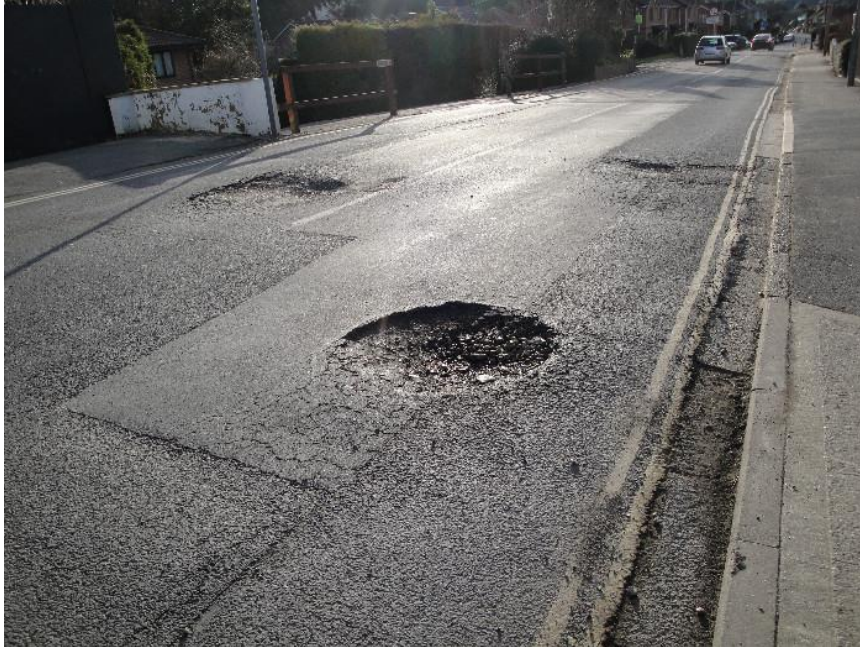
- Good Base
- Isolated Repair

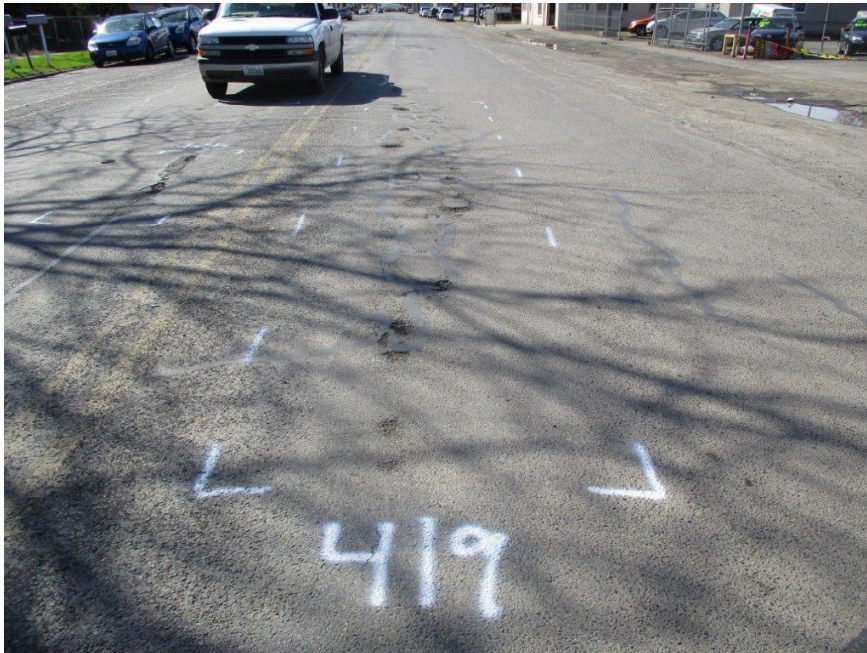
- Good Base
- Narrow Strip Repair

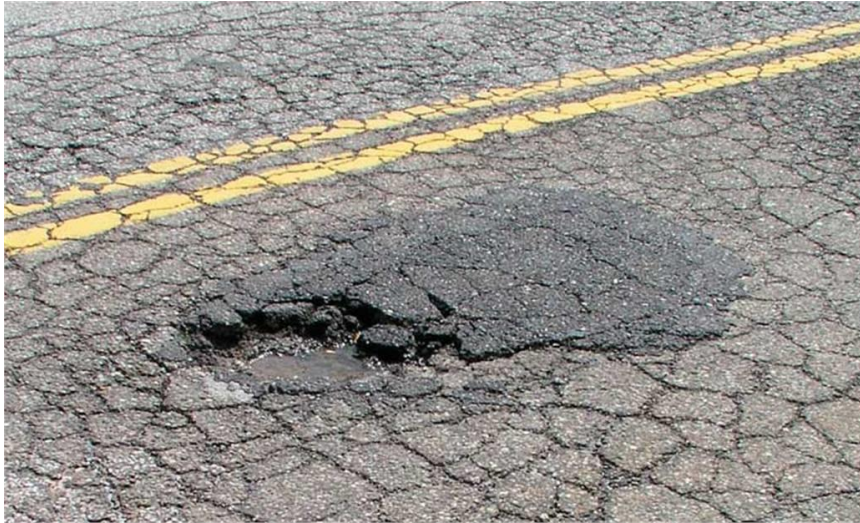
-Greater than 25% distressed

-Correct treatment is reconstruction

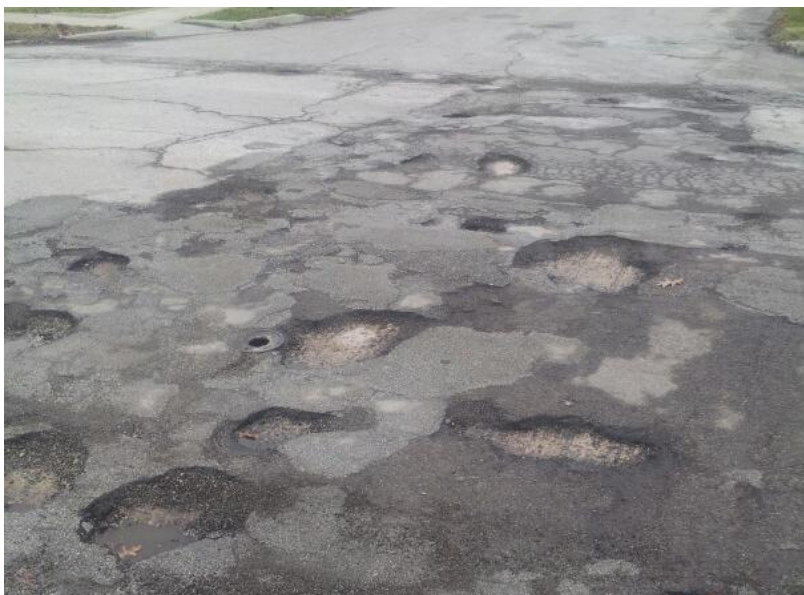
-History of failure

-Greater than 25% distressed

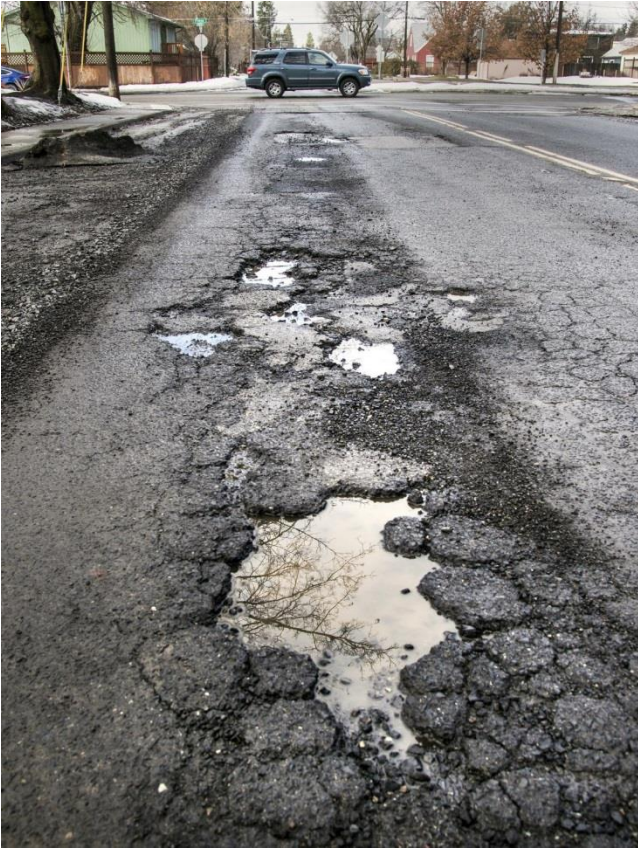
-The correct treatment requires more than patching

-Greater than 25% distressed

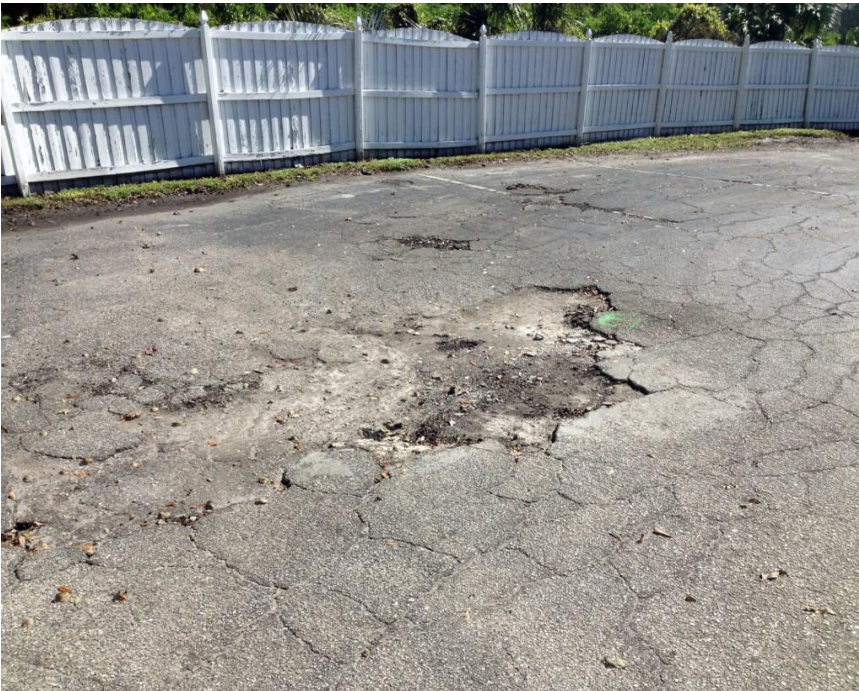
-No Base

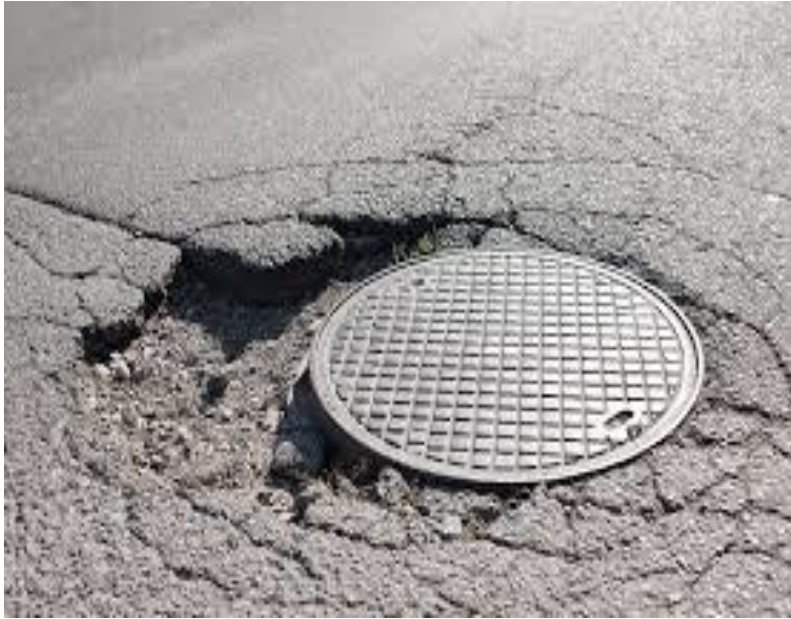
-Bad workmanship

-Pavement in too good of condition to be considered "emergency"

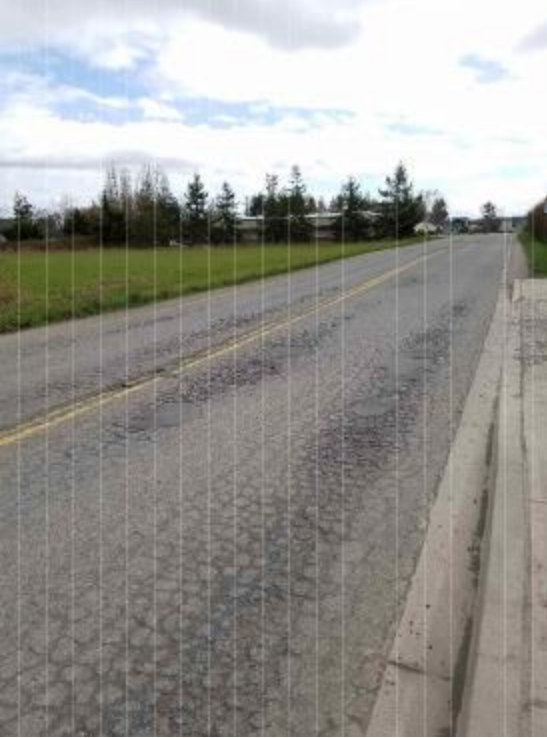
- The correct treatment requires more than patching

-Greater than 25% distressed

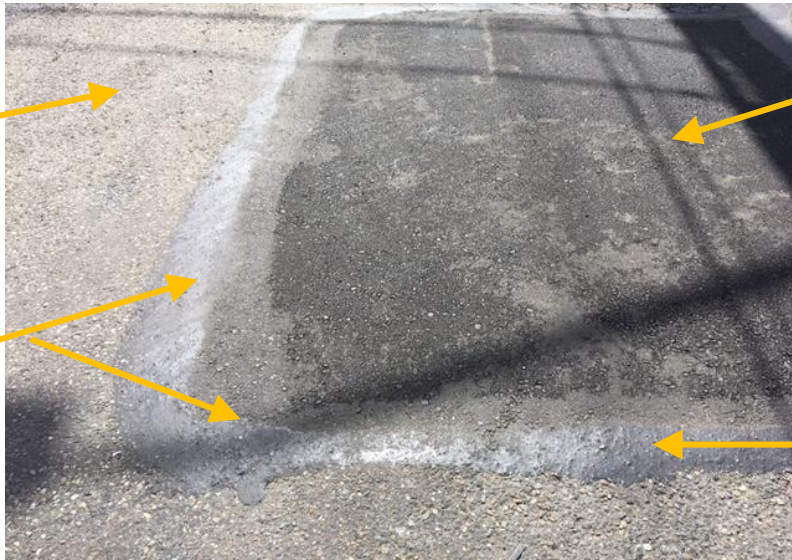
Non-distressed  
adjoining pavement

Sawcut or grind  
vertical edges

Smooth compacted  
asphalt surface

Sealed edges
